**Flood Control Project Maintenance
Levee Inspections
LMA District Cover Sheet
Spring 2010 Levee Inspection Results**

Reclamation District No. 2064 River Junction

Spring 2010 Levee Inspection Results

Waterway			Bank	Unit Miles
Unit No. 01 San Joaquin River			Right	5.70
	Spring (March - May)	Summer (June - August)	(September - November) Fall	Winter (December - February)
Unit Maintenance Rating (Fall Only)				
Date of Inspection	4/28/2010 - 4/28/2010			
DWR Inspector	Herman Phillips			
Accompanied By	Mr. Roy Boyd RD 2064

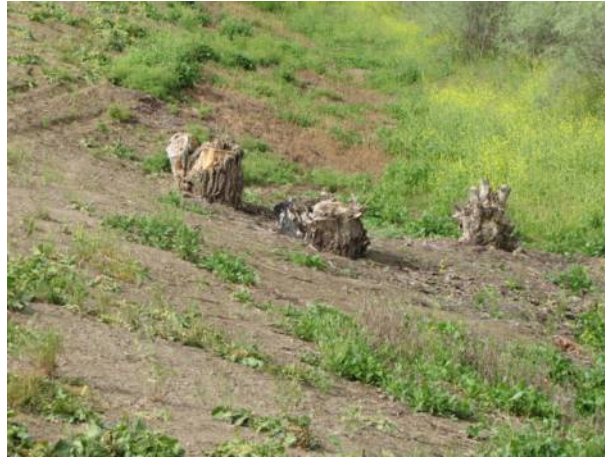
Levee mile 0.71

Levee Mile Report Line	1
Start Levee Mile	0.71
End Levee Mile	0.71
Location	Water Side
Category	Earthen Levee
Item	Trim / Thin Trees

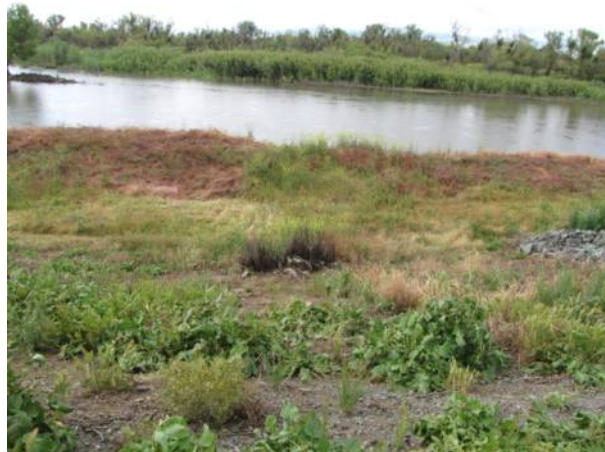
Levee mile 2.43

Levee Mile Report Line	2
Start Levee Mile	2.43
End Levee Mile	2.43
Location	Water Side
Category	Earthen Levee
Item	Trim / Thin Trees

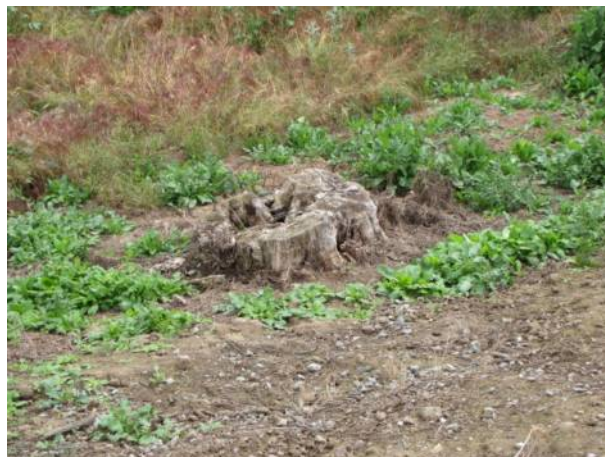
Levee mile 3.29 land side toe.

Levee Mile Report Line	3
Start Levee Mile	3.29
End Levee Mile	3.29
Location	Land Side
Category	Earthen Levee
Item	Trim / Thin Trees

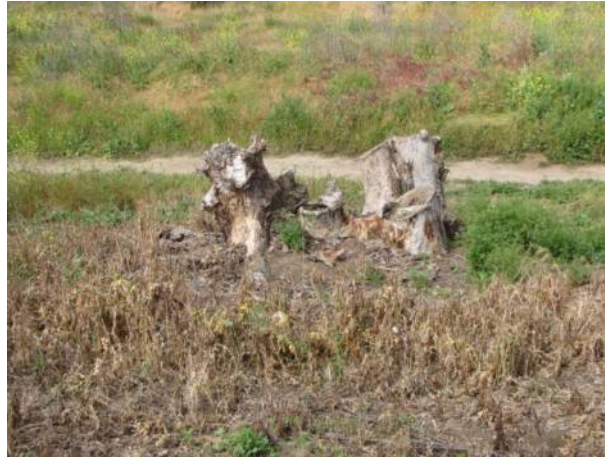
Levee mile 3.53

Levee Mile Report Line	4
Start Levee Mile	3.53
End Levee Mile	3.53
Location	Water Side
Category	Earthen Levee
Item	Trim / Thin Trees

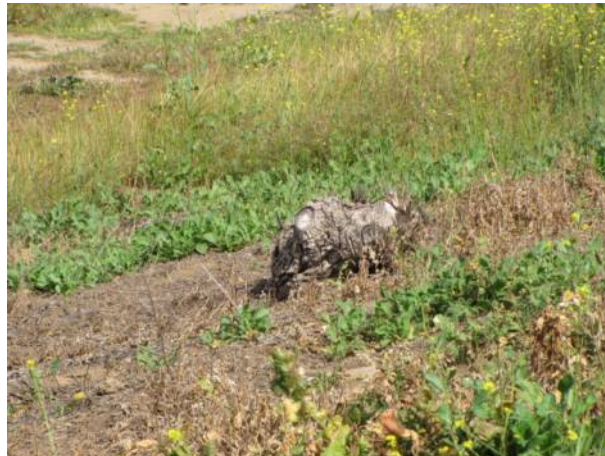
Levee mile 3.55

Levee Mile Report Line	5
Start Levee Mile	3.55
End Levee Mile	3.55
Location	Land Side
Category	Earthen Levee
Item	Trim / Thin Trees

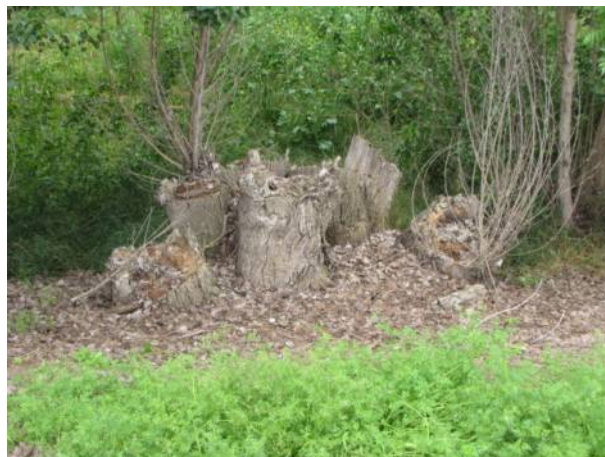
Levee mile 3.66 waterward toe.

Levee Mile Report Line	6
Start Levee Mile	3.66
End Levee Mile	3.66
Location	Land Side
Category	Earthen Levee
Item	Trim / Thin Trees

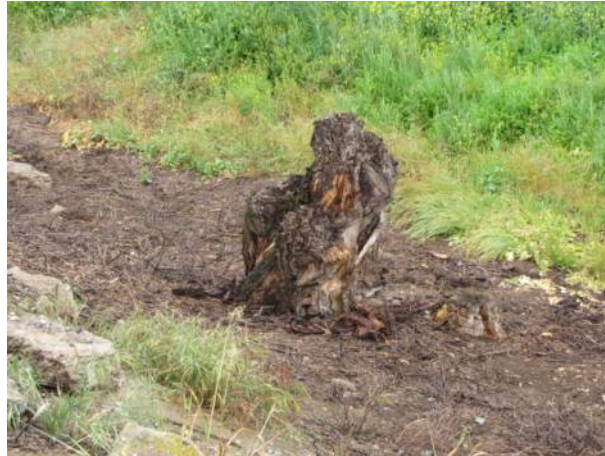
levee mile 0.99

Levee Mile Report Line	2
Start Levee Mile	0.99
End Levee Mile	0.99
Location	Water Side
Category	Earthen Levee
Item	Trim / Thin Trees

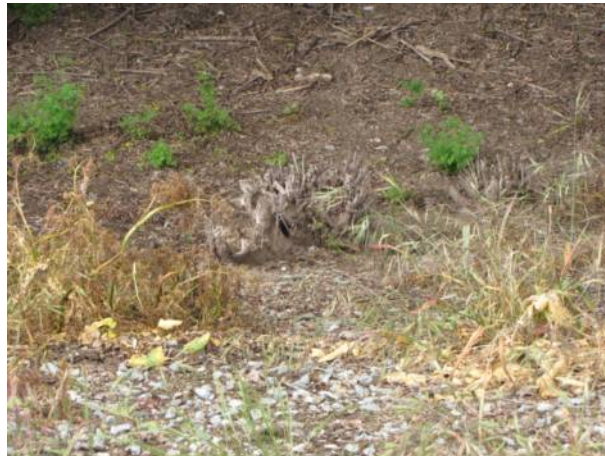
levee mile 1.76

Levee Mile Report Line	4
Start Levee Mile	1.76
End Levee Mile	1.76
Location	Land Side
Category	Earthen Levee
Item	Trim / Thin Trees

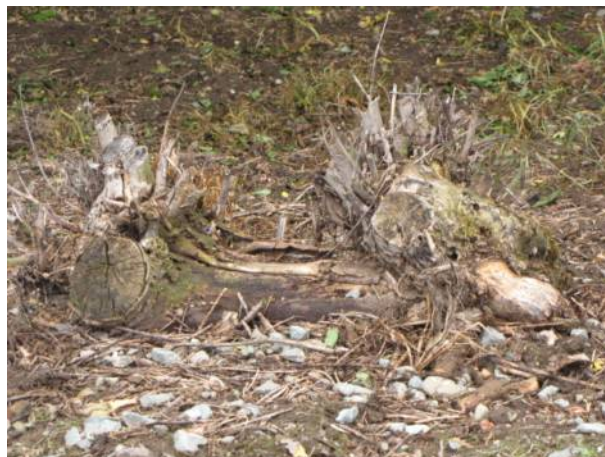
levee mile 1.78

Levee Mile Report Line	5
Start Levee Mile	1.78
End Levee Mile	1.78
Location	Land Side
Category	Earthen Levee
Item	Trim / Thin Trees

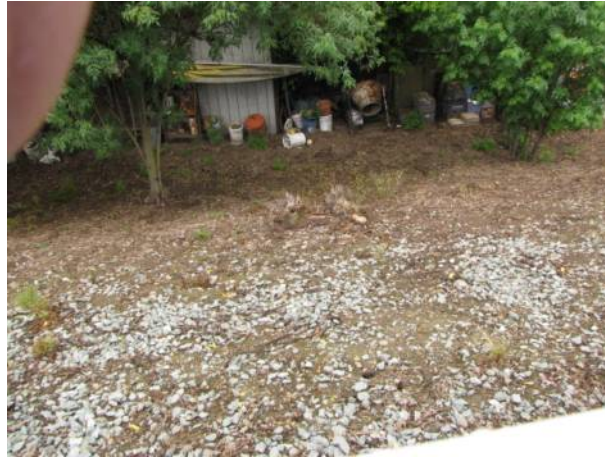
levee miles 1.79-1.81

Levee Mile Report Line	6
Start Levee Mile	1.79
End Levee Mile	1.81
Location	Land Side
Category	Earthen Levee
Item	Trim / Thin Trees

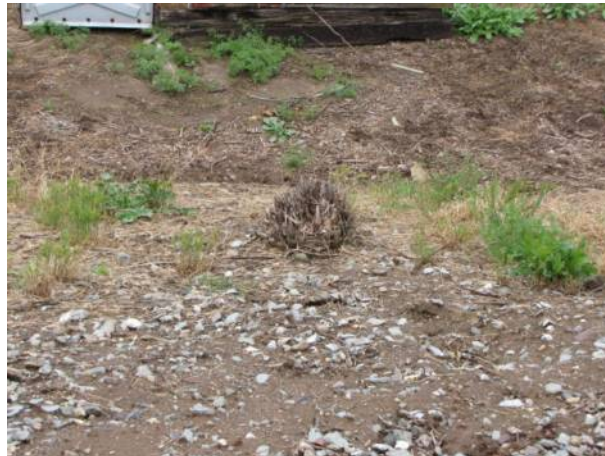
Levee mile 1.86

Levee Mile Report Line	7
Start Levee Mile	1.86
End Levee Mile	1.86
Location	Land Side
Category	Earthen Levee
Item	Trim / Thin Trees
